I-94 East-West Corridor Study Visual Impact Assessment

PREPARED BY: Mark Greenig/CH2M HILL, Ben Goldsworthy/CH2M HILL
COPIES: File
DATE: September, 2014

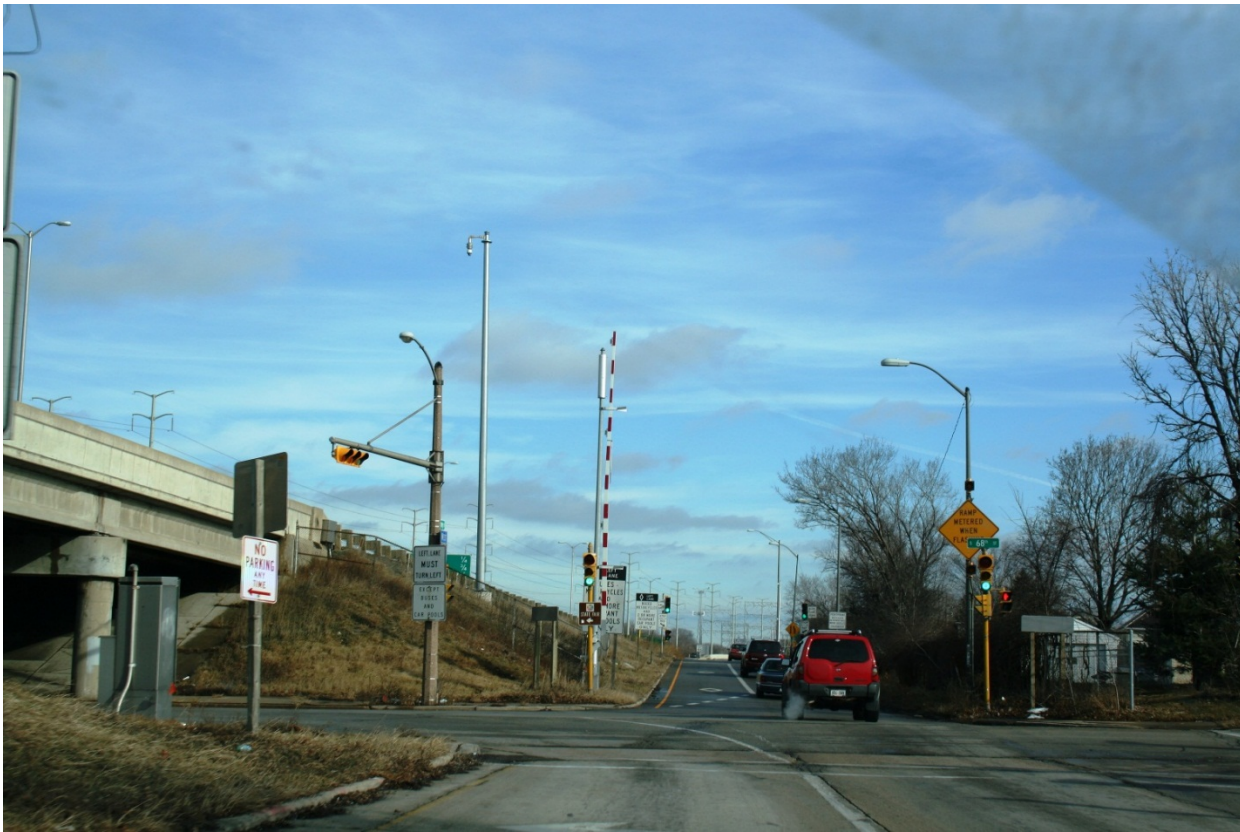
Exhibit A-3: Location 1 (Landscape Unit 1) From eastbound W. Kearny Street just west of S. 68th Street looking east at I-94 overpass over S. 68th Street and the east-bound onramp to I-94.

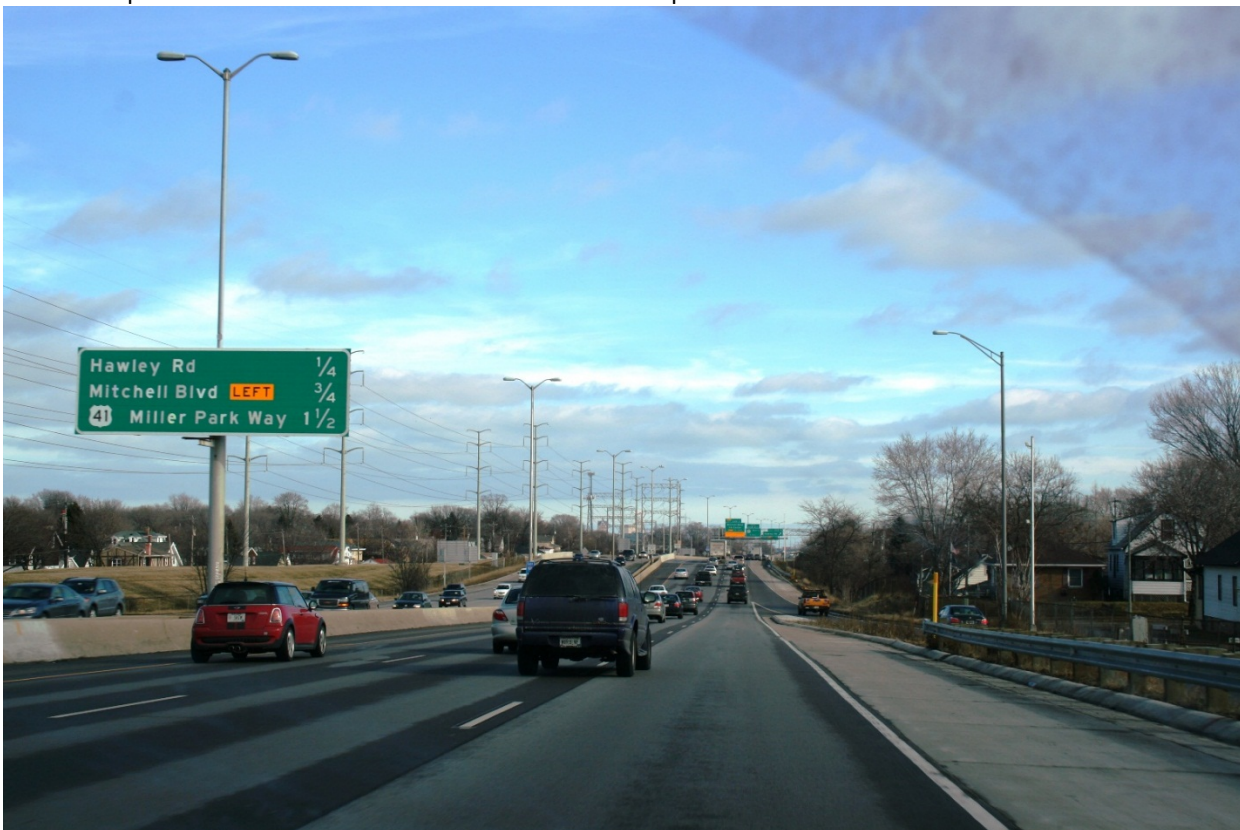
Exhibit A-4: Location 2 (Landscape Unit 1) From eastbound I-94 east of S. 68th Street looking east.

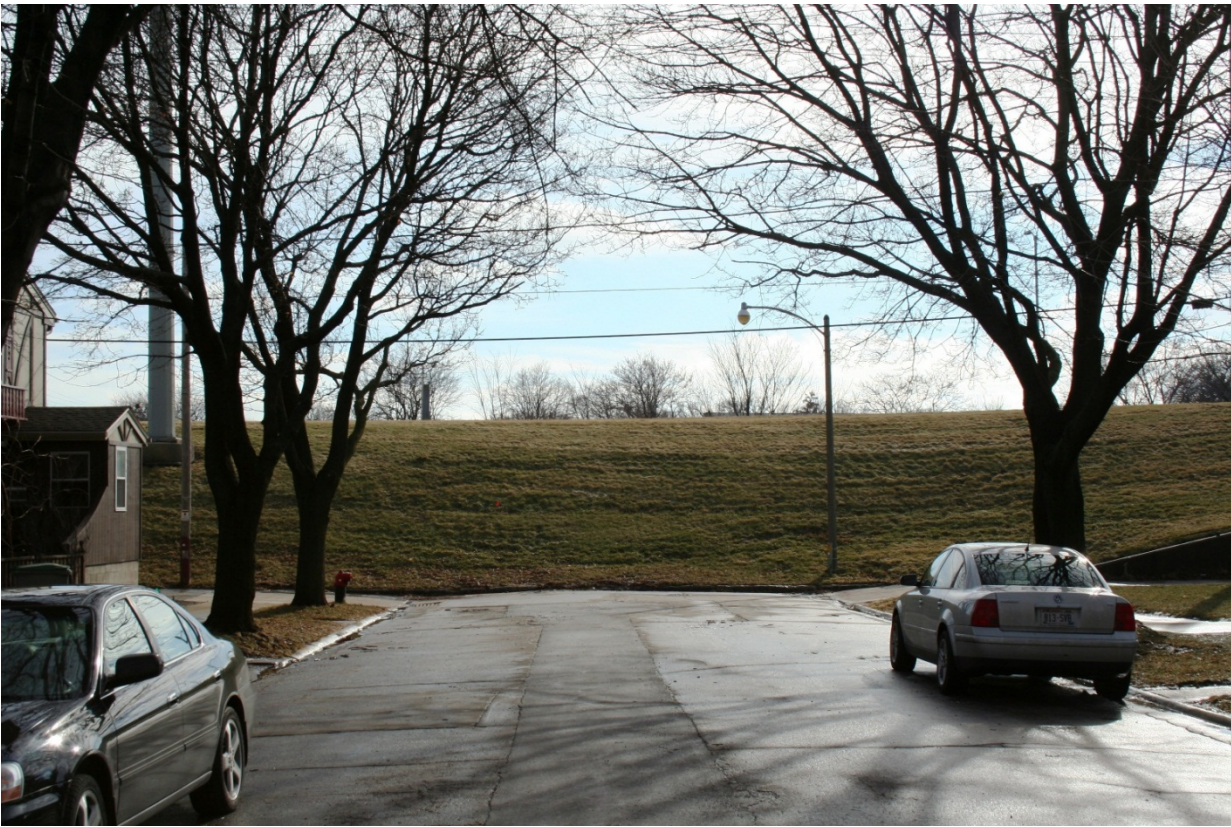
Exhibit A-5: Location 3 (Landscape Unit 1) From S. 65th Street south of W. Fairview Avenue looking south towards the 138 kV electrical transmission line right-of-way embankment.

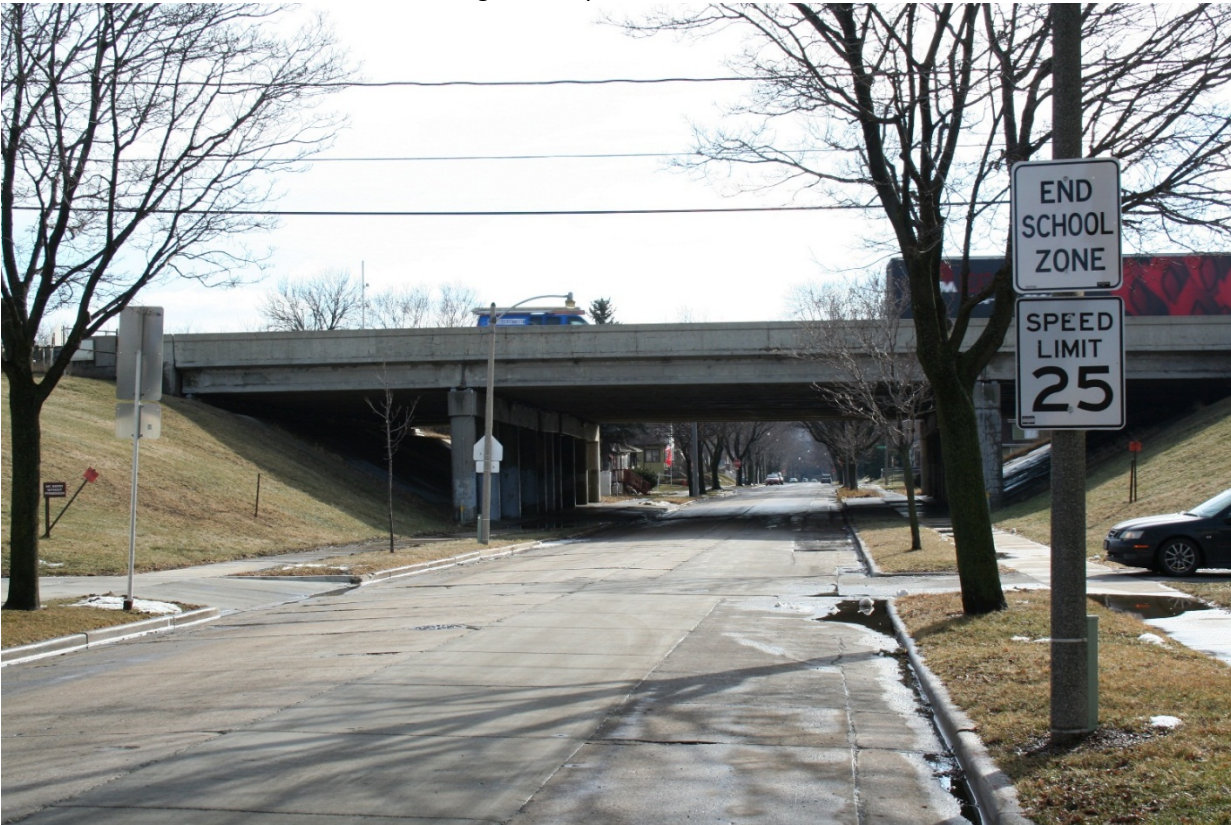
Exhibit A-6: Location 4 (Landscape Unit 1) From S. 64th Street north of W. Dixon Street looking north at I-94 overpass over 64th Street.

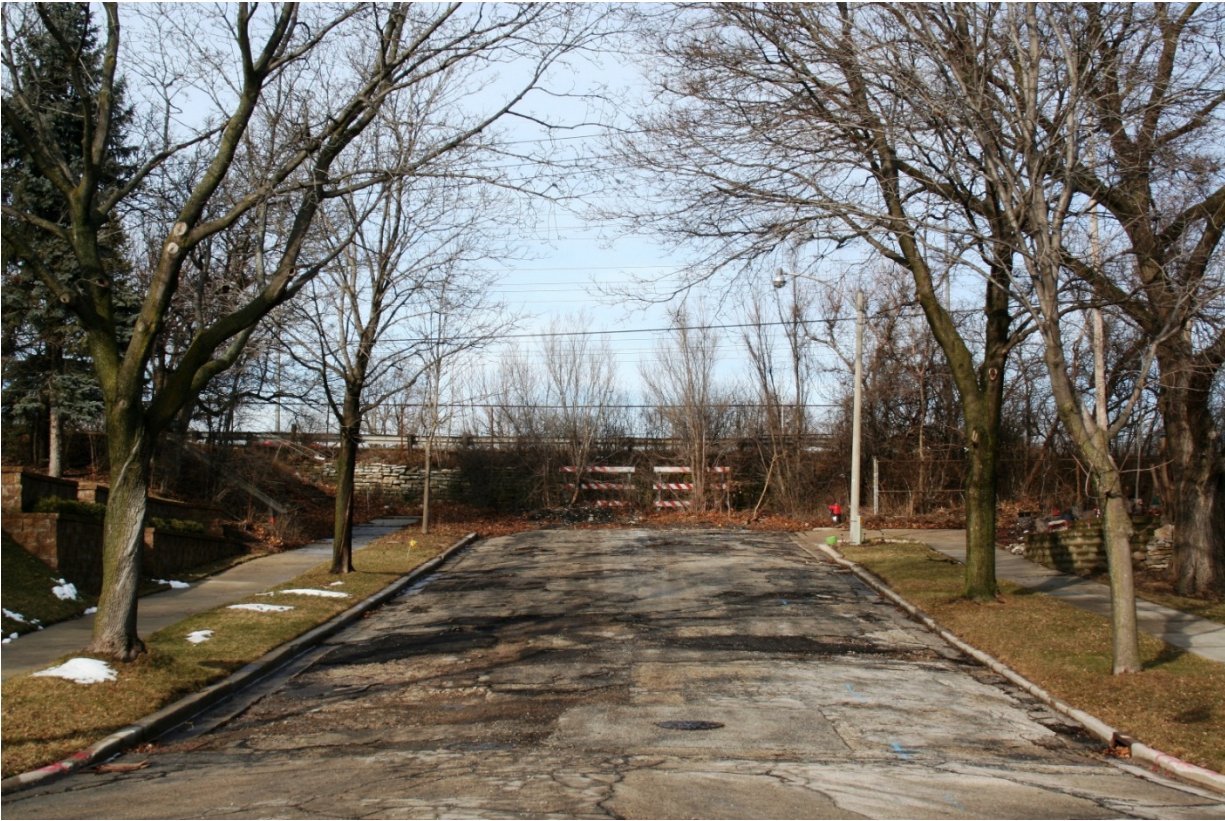
Exhibit A-7: Location 5 (Landscape Unit 1) From S. 61st Street north of W. Dixon Street looking north at the end of the street adjacent to I-94.

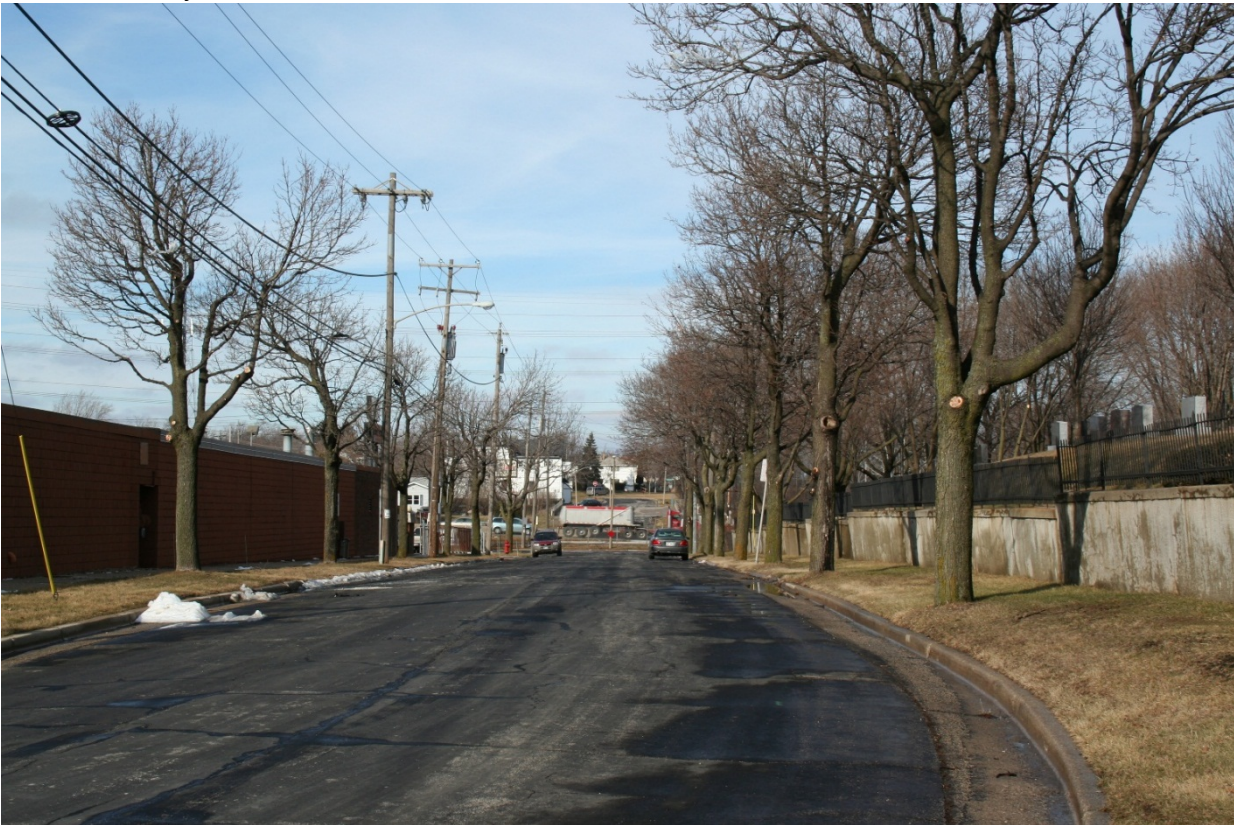
Exhibit A-8: Location 6 (Landscape Unit 2) From S. Hawley Court southeast of the Hunger Task Force building looking north at end of street adjacent to I-94.

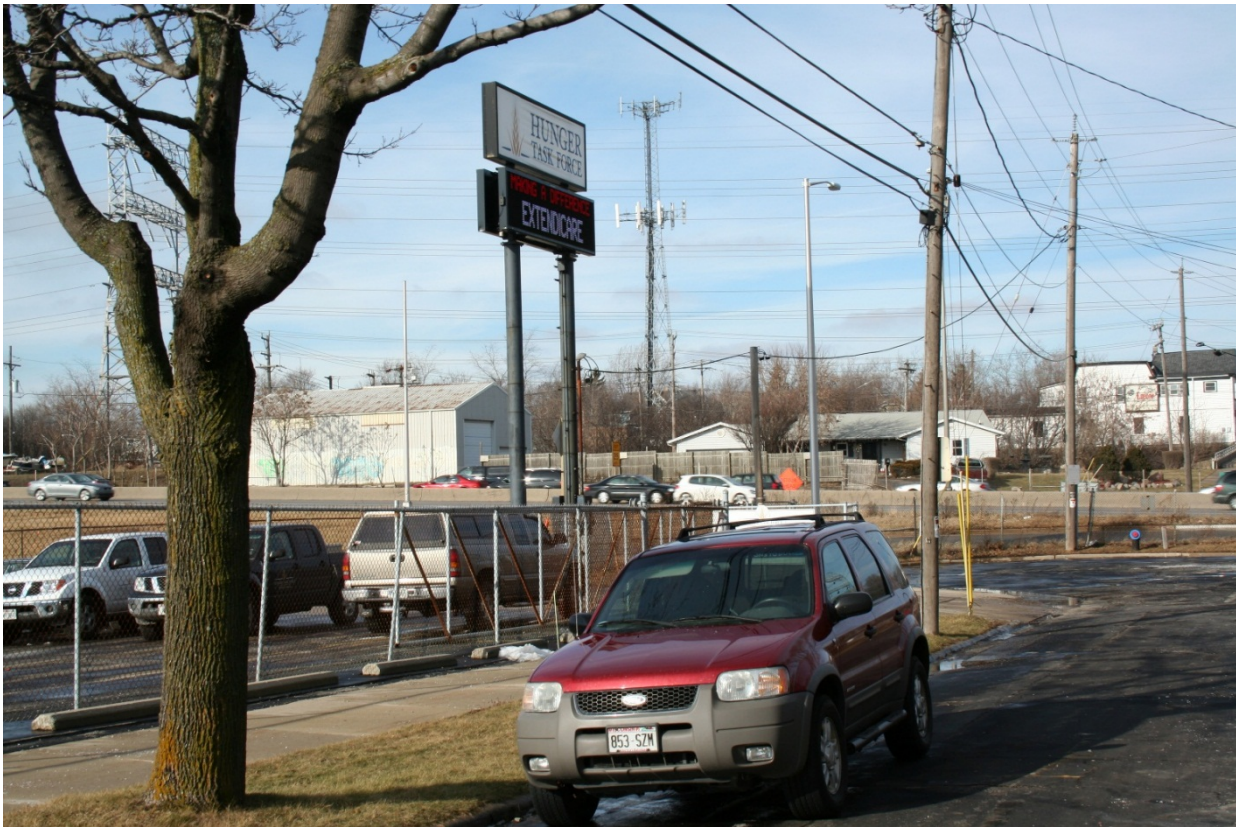
Exhibit A-9: Location 7 (Landscape Unit 2) From S. Hawley Court northeast of the Hunger Task Force building looking northwest at I-94 . Note vehicles on I-94.

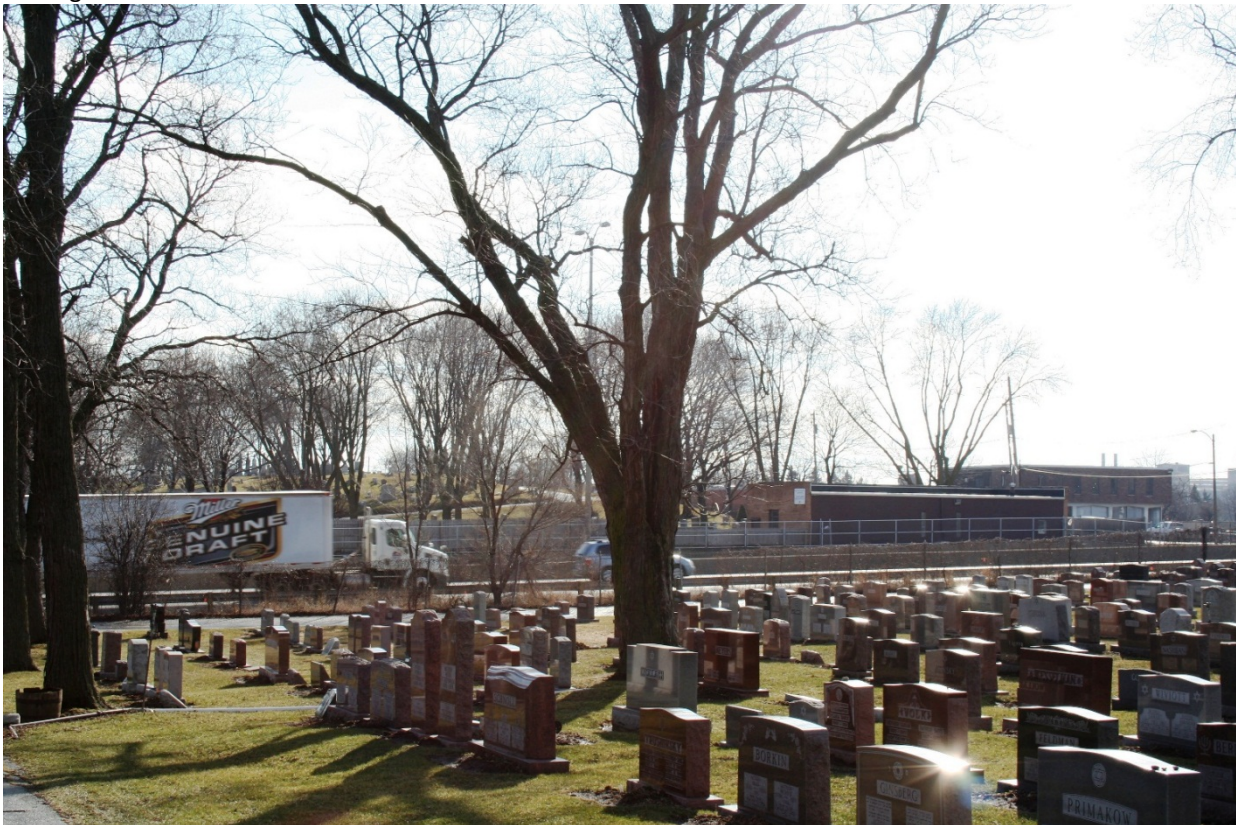
Exhibit A-10: Location 8 (Landscape Unit 2) From Beth Hamedrosh Hagodel Cemetery access road looking southwest at I-94 and the Spring Hill Cemetery mausoleum (the building on the right side of photograph adjacent to I-94). .

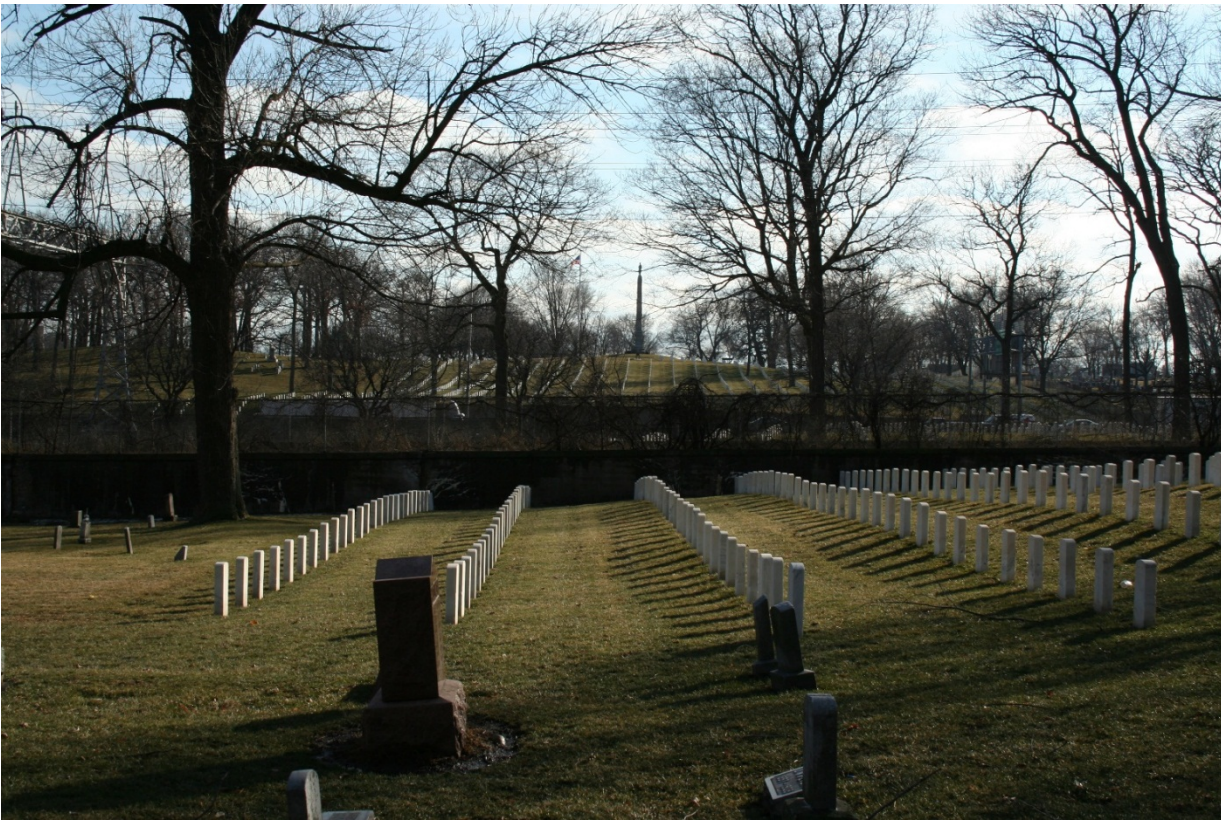
Exhibit A-11: Location 9 (Landscape Unit 2) From the north Wood National Cemetery parcel looking south at I-94 and the main part of Wood National Cemetery.

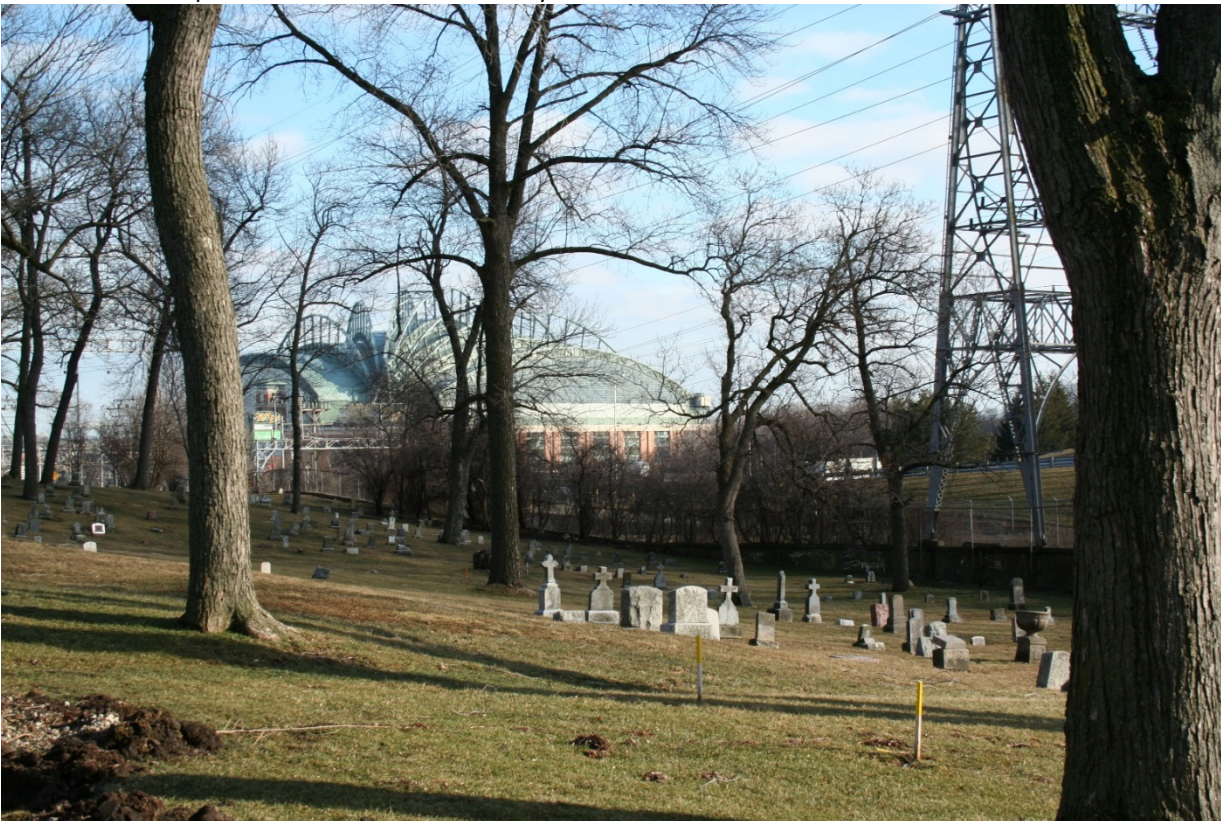
Exhibit A-12: Location 10 (Landscape Unit 2) From the Calvary Cemetery access road north of the _kV electrical transmission line corridor looking southeast.

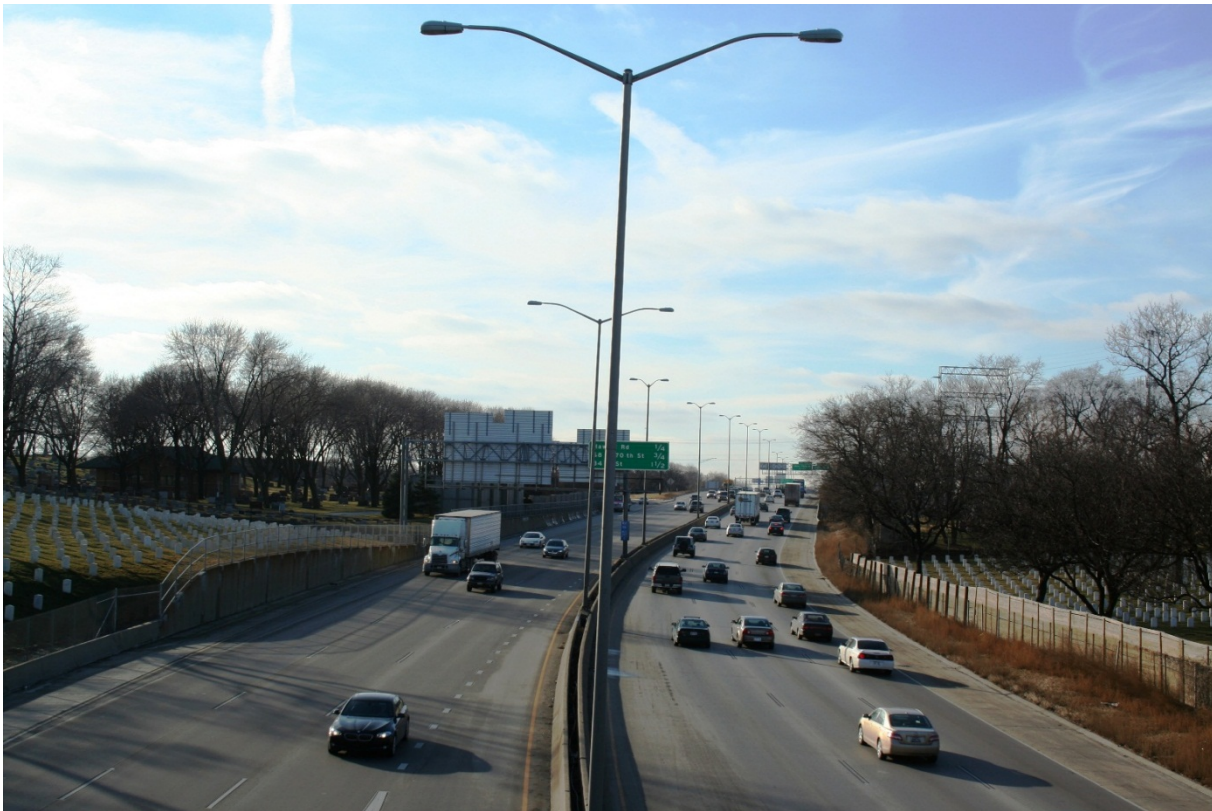
Exhibit A-13: Location 11 (Landscape Unit 2) From Zablocki Drive bridge over I-94 looking west over I-94. Note the main part of Wood National Cemetery on left (south) side of I-94 and the north parcel on the right (north) side.

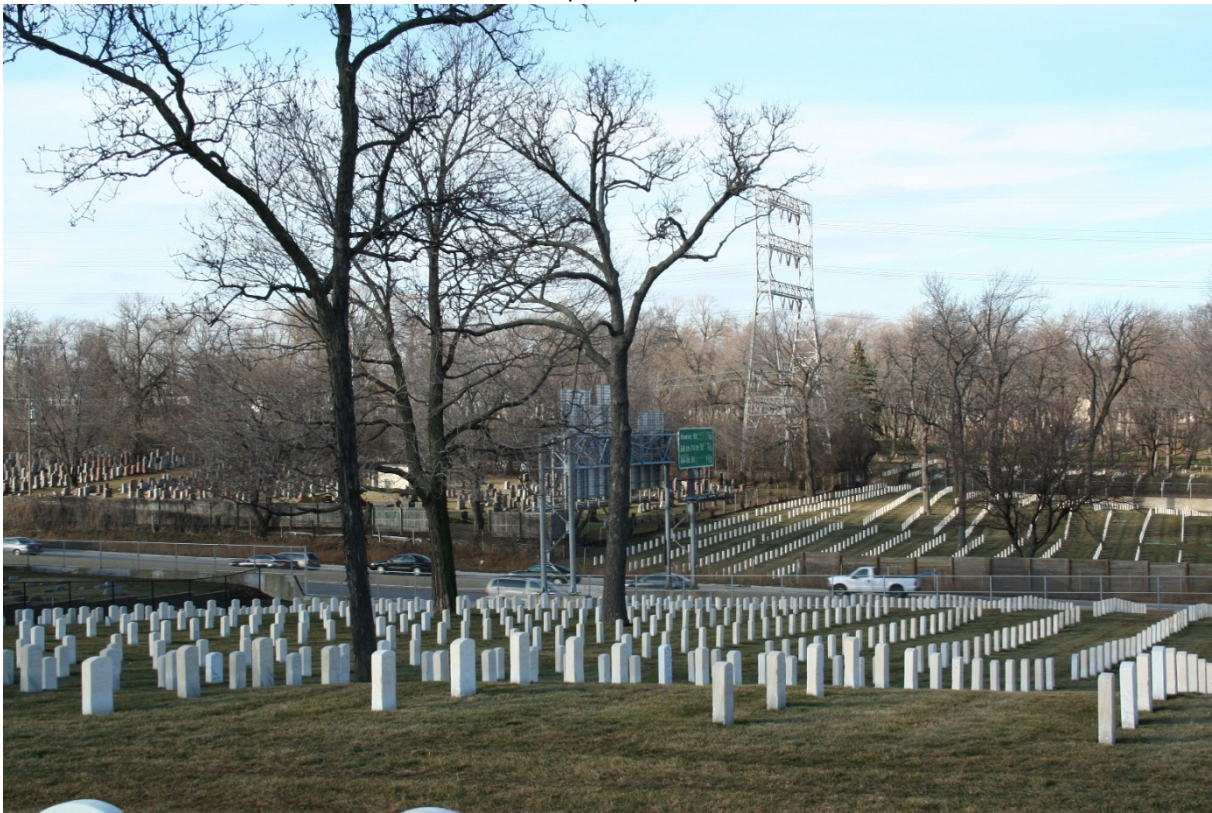
Exhibit A-14: Location 12 (Landscape Unit 2) From main part of Wood National Cemetery looking north at I-94 and north parcel of the cemetery.

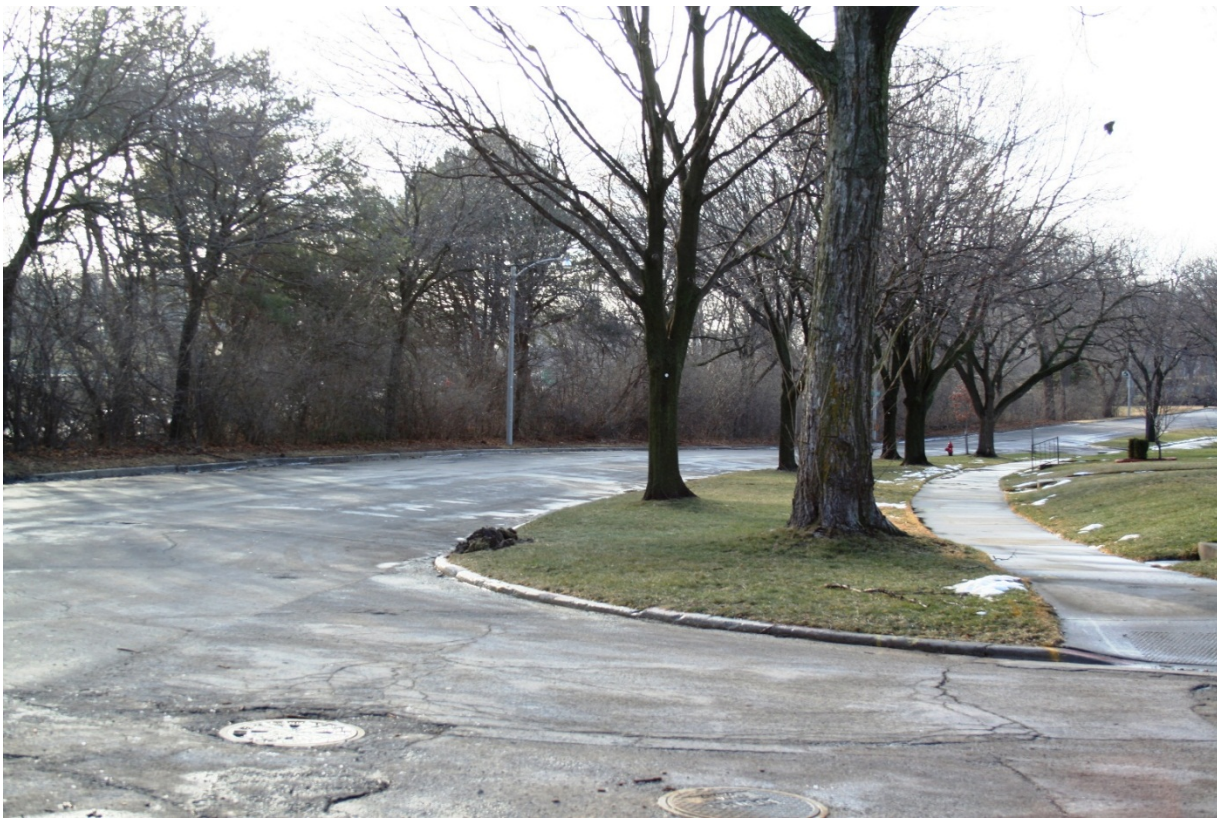
Exhibit A-15: Location 13 (Landscape Unit 3) From intersection of N. Story Parkway and N. Pinecrest Street looking west along N. Story Parkway. Note the vegetation along the south side of the parkway that provides varying degrees of screening.

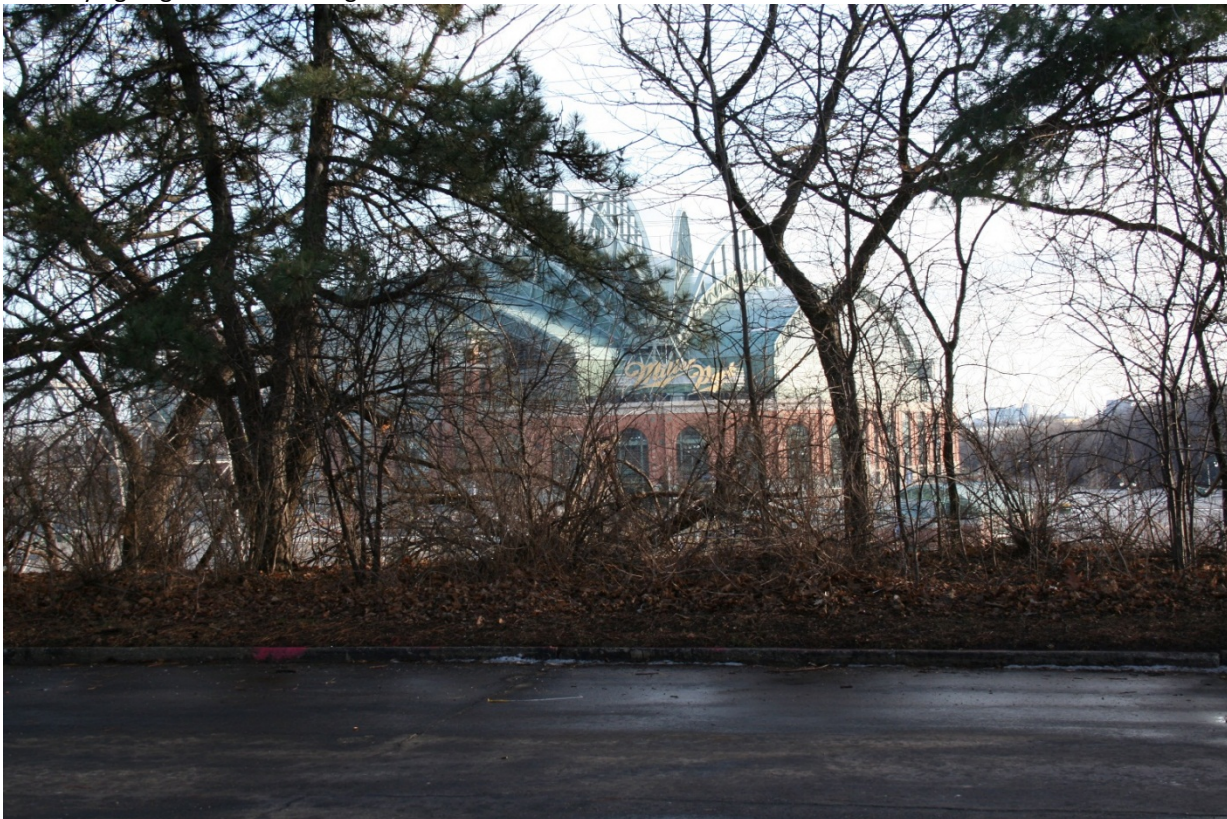
Exhibit A-16: Location 14 (Landscape Unit 3) From N. Story Parkway looking south towards Miller Park.

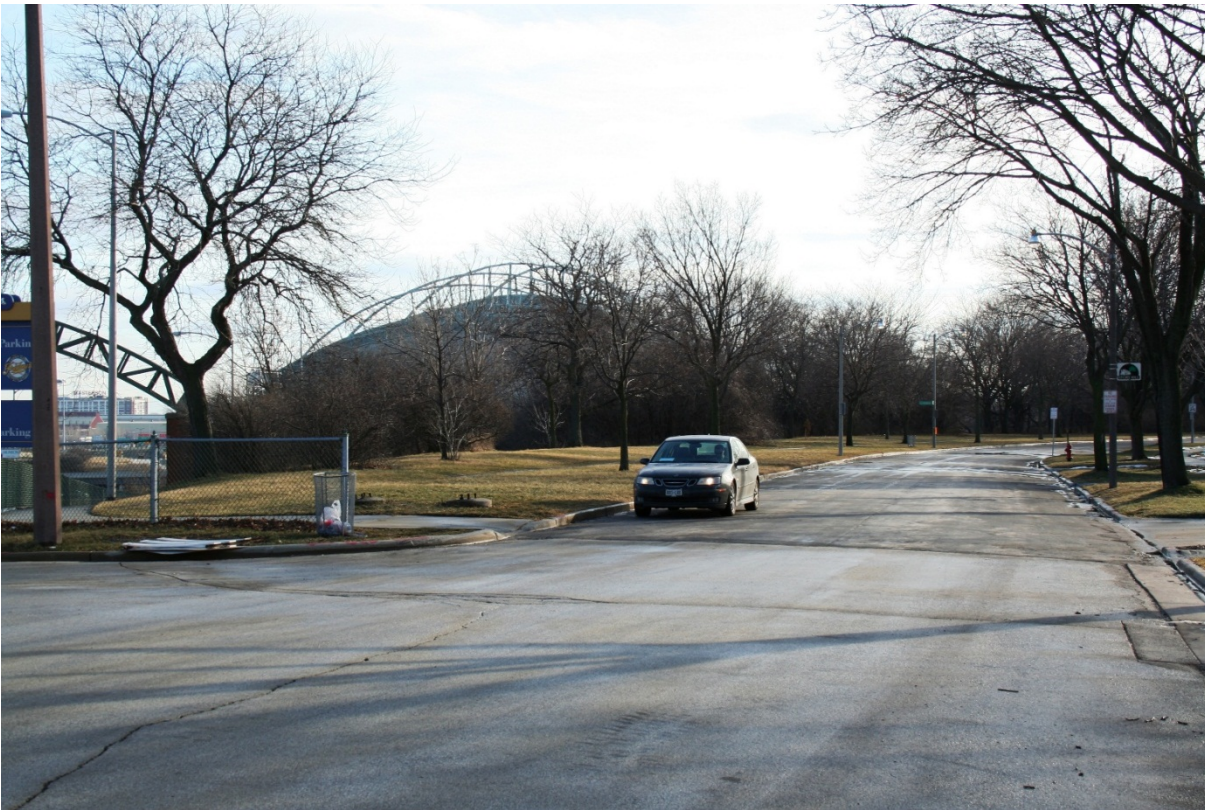
Exhibit A-17: Location 15 (Landscape Unit 3) From the intersection of N. Story Parkway and Yount Drive looking south at Miller Park and along N. Story Parkway.

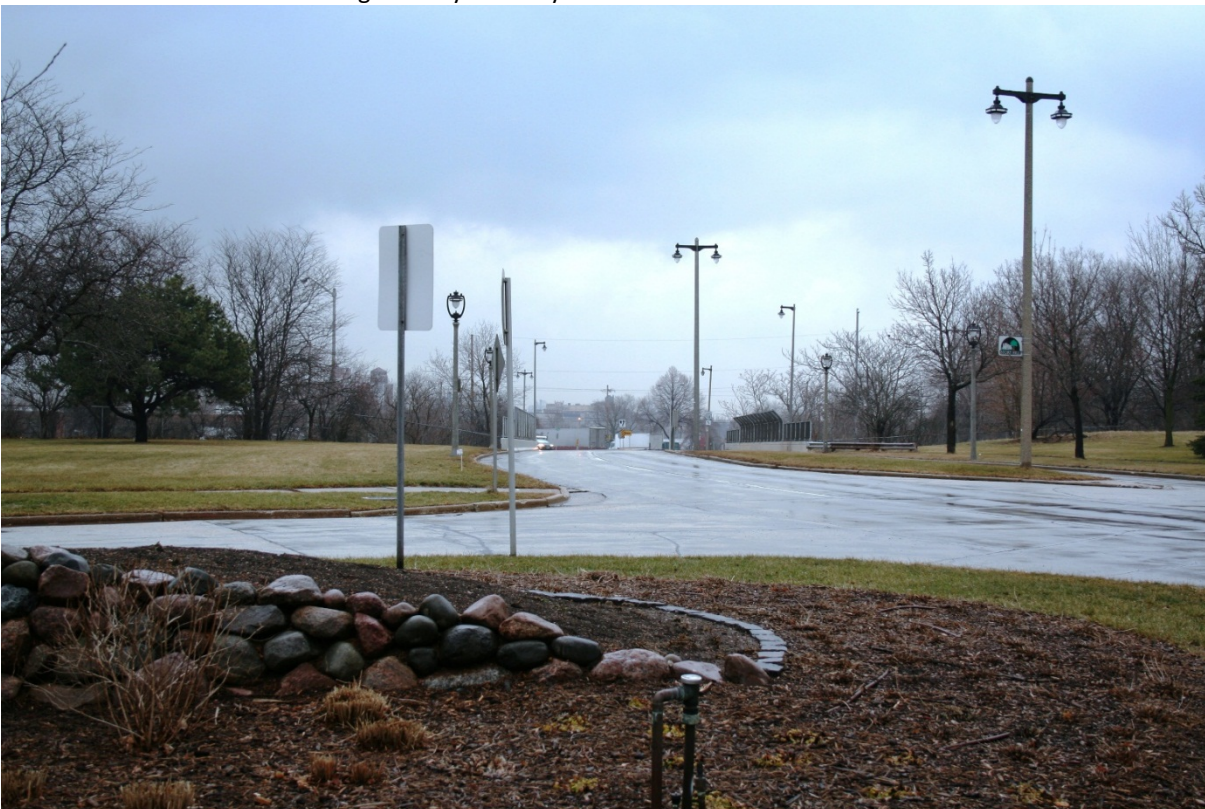
Exhibit A-18: Location 16 (Landscape Unit 3) From northwest quadrant of the intersection of N. Story Parkway and W. Bluemound Road looking east along W. Bluemound Road towards it's overpass over WIS 41..

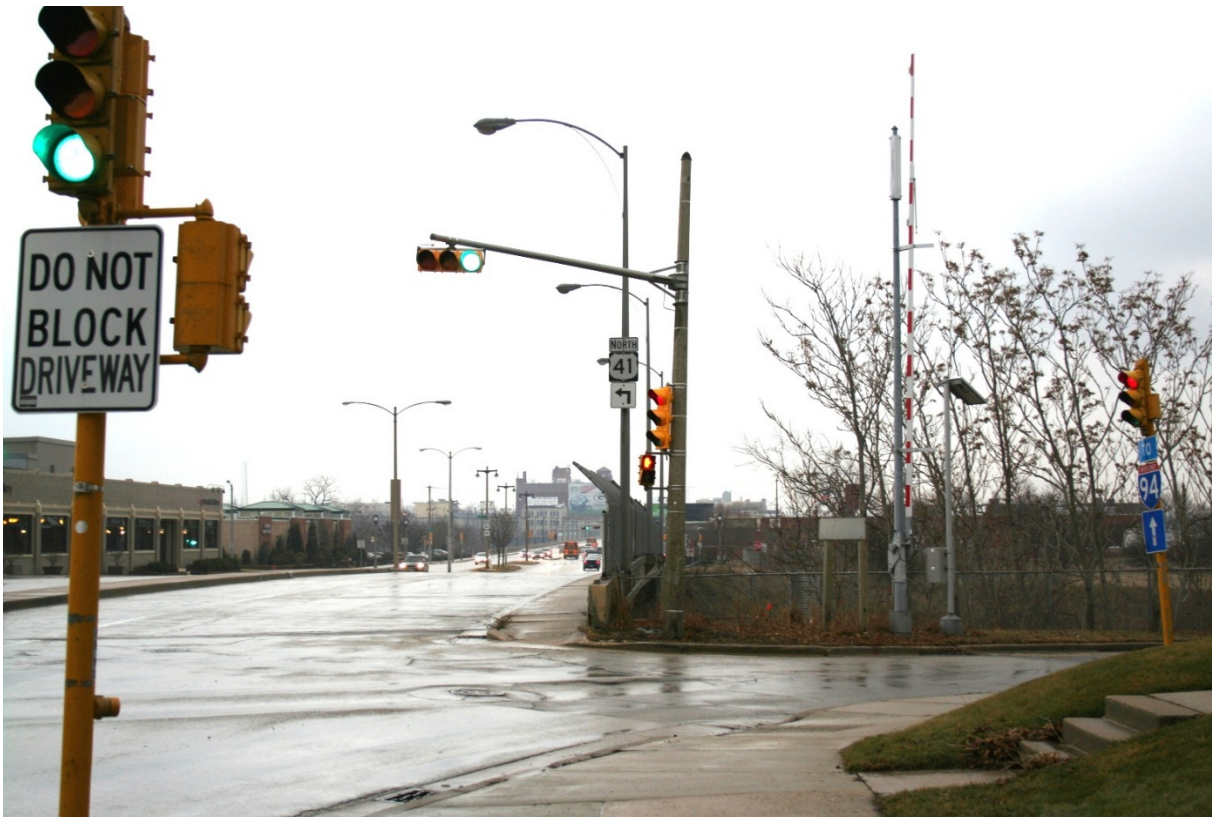
Exhibit A-19: Location 17 (Landscape Unit 3) From southwest quadrant of W. Wisconsin Avenue/US 41 interchange looking east along W. Wisconsin Avenue towards the WIS 41 overpass.

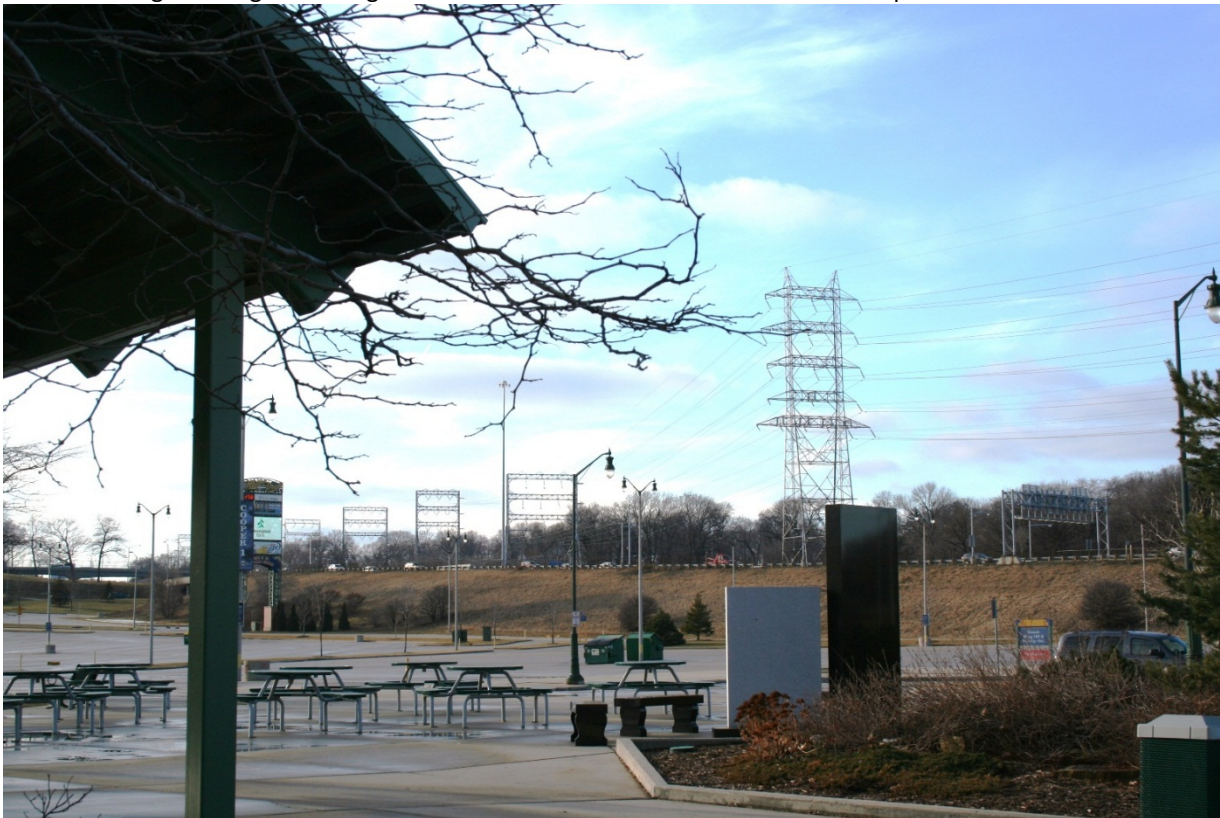
Exhibit A-20: Location 18 (Landscape Unit 4) From Helfaer Field in the Miller Park parking lot south of I-94 looking northwest at I-94 and Story Hill behind it.

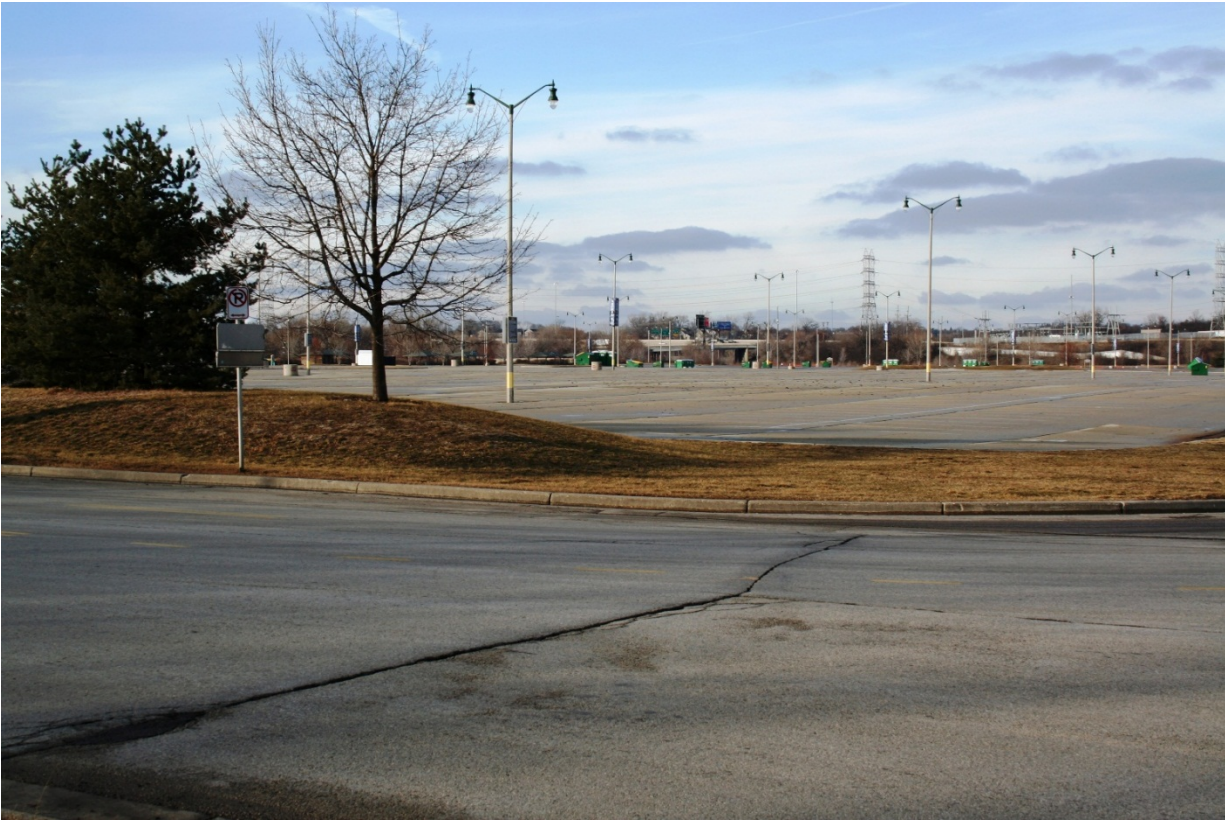
Exhibit A-21: Location 19 (Landscape Unit 4): From the intersection of Frederick Miller Way/W. Canal Street and Selig Drive (and the Hank Aaron Trail) looking northwest towards I-94.

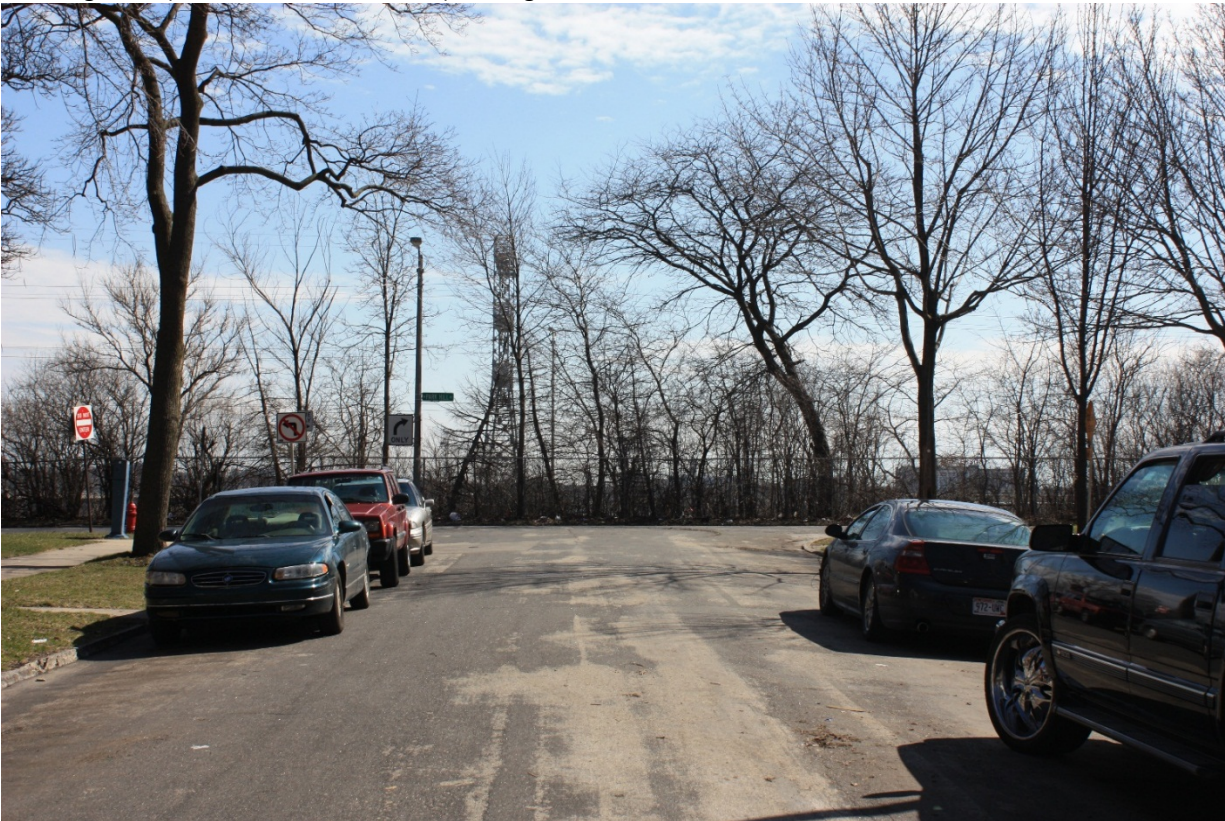
Exhibit A-22: Location 20 (Landscape Unit 5) From N. 37th Street north of W. Park Hill Avenue looking south over I-94.

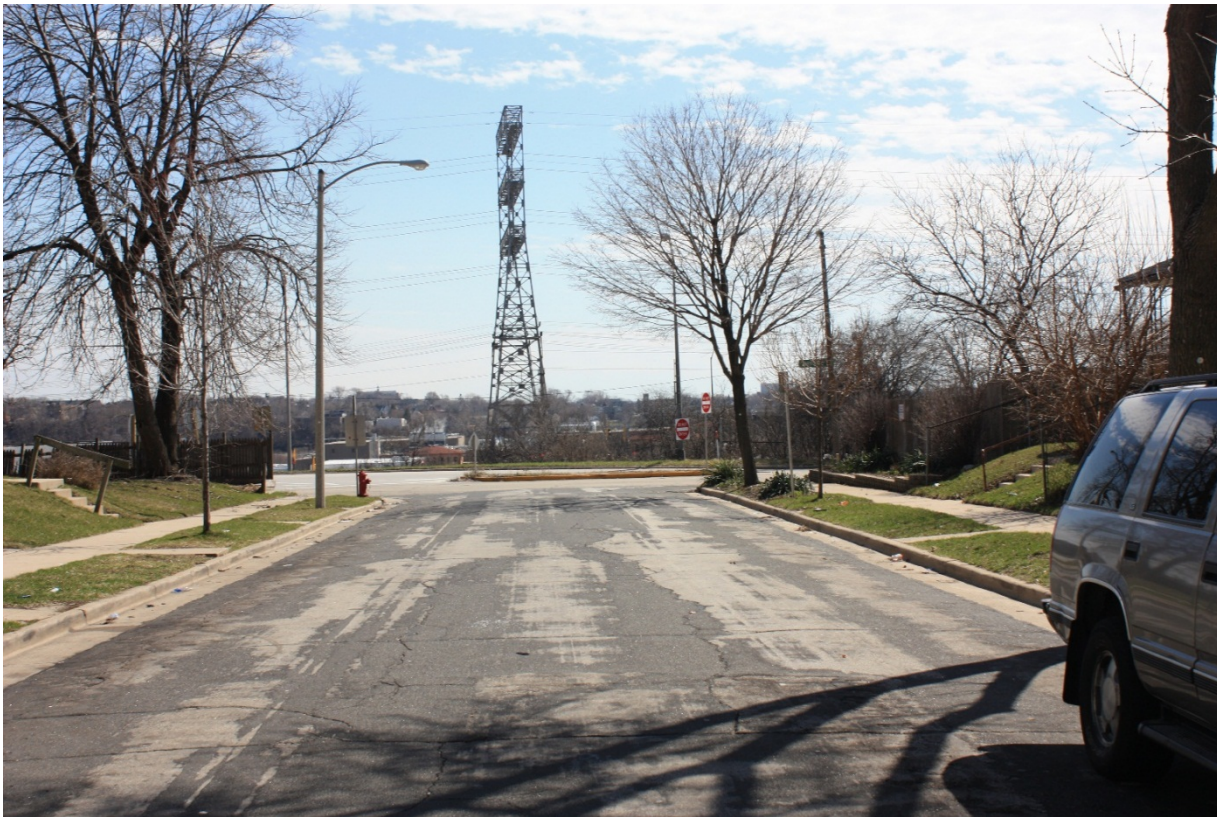
Exhibit A-23: Location 21 (Landscape Unit 5) From N. 34th Street north of W. Park Hill Avenue looking south at W. Park Hill Avenue and exit of off-ramp from I-94.

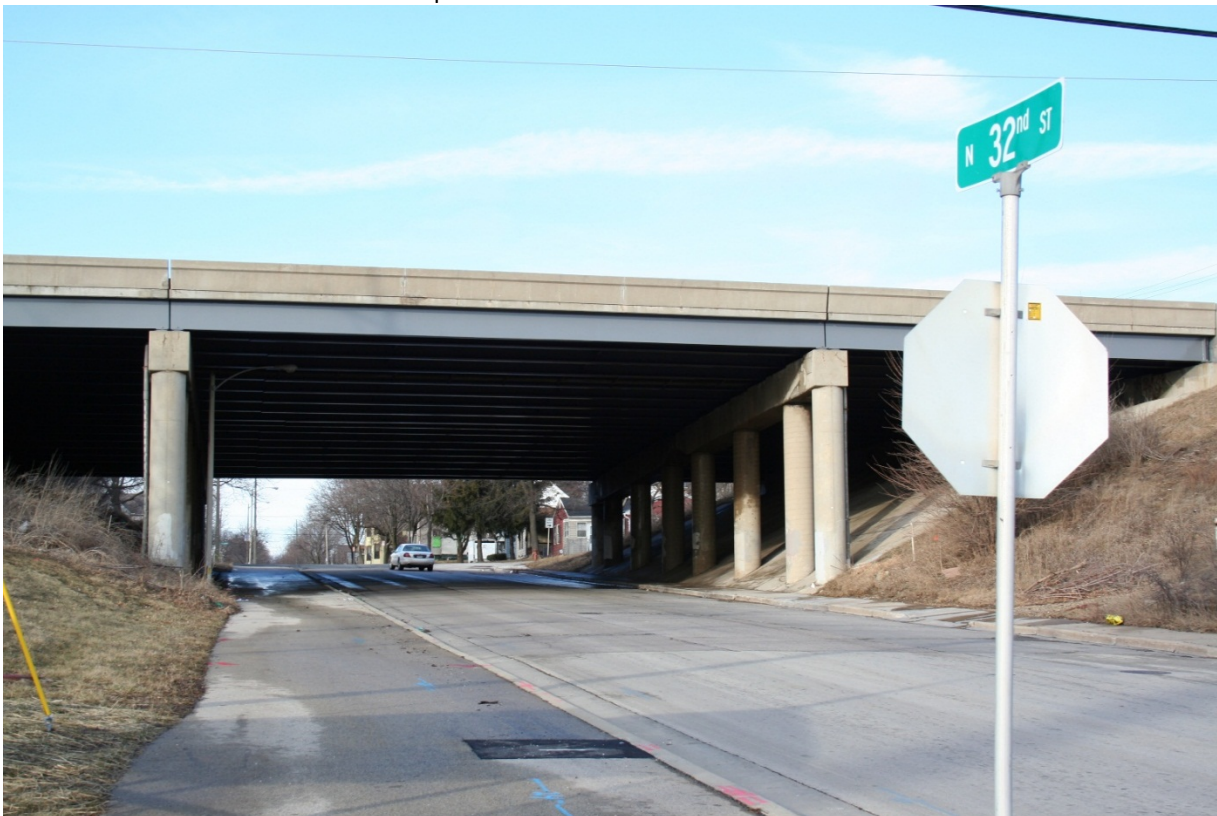
Exhibit A-24: Location 22 (Landscape Unit 6) From the intersection of N. 32nd Street and W. Canal Street looking north at I-94 overpass over N. 32nd Street.
